**NORTHERN RURAL INFRASTRUCTURE
DEVELOPMENT SECTOR PROJECT**

**SAFEGUARD MONITORING
OF PACKAGE 7-2 FOR
YEAR 2014**

**First Mission Report
Safeguard Monitoring and Evaluation Report**

Faculty of Environmental Sciences
National University of Laos

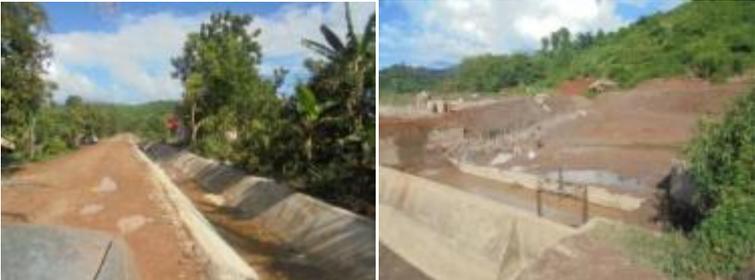
Disturbance of water flows	Proposed mitigation and required action
Soil erosion, silt and sediment deposition	
This Subproject is located in the flat land and the canal alignments go along the low terrain areas. No severe erosion and landslide observed during the site visit and most of the area along canal sides are stabilized compacted, no potential impact of erosion on villagers paddy fields or stream flow. The small section within the silted weir basin which is being clearing and levelling for concrete lining of wings both upstream and downstream of weir, but this would not cause significant erosion and sediment transport.	Rehabilitation along the canal sides where necessary upon the completion of earth works to avoid the potential impact to the paddy fields of the villagers.

Photos of the construction site concerning erosion	
Disturbance on Water Flow	
With low flow of Nam Pouk, very limited water available in the stream and the water were temporarily blocked due to de-silting and concrete lining work close to the weir structure and no disturbance on water use for irrigated paddy fields.	It is recommended that during the operation the minimum flow should be released to the downstream during the high demand for irrigation to maintain the water required for aquatic resources.

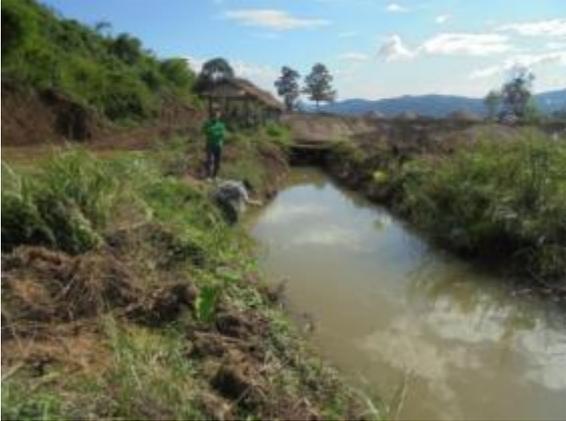
Photo of the water low water flow of Nam Pouk	
Dust and Noise Nuisance	
<p>As the canal alignment and road pave with gravel passes through the residential area. However, only few trucks and vehicles used during the construction and the works was only carried out during the day time and the main construction area where the machineries are needed is quite far from the communities. Therefore, the concerns associated with dust and noise is quite minor.</p>	<p>Operation of heavy machineries at night time should be minimize and the speed limit for the driving in the residential area to minimize the dust suppression.</p>
Borrow Pits/Quarry	
<p>No borrow pit and quarry on site. Aggregates for construction were supplied by the local supplier.</p>	<p>No actions or mitigation measures required</p>
Waste Management.	
<p>In general, the temporary accommodation during the construction was provided with good housekeeping with waste pit, arrangement of facilities was acceptable</p>	<p>It is recommended that the PPO and DCO in coordination with PONRE or DONRE has to check and monitor the general housekeeping and waste management on site when the construction work restart again.</p>

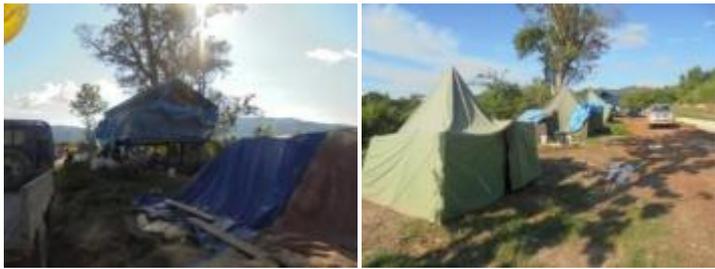
Construction Camp	
<p>One agricultural hut and few tents were used as accommodation and the toilets were provided. It was confirmed by the Contractor that the accommodation will be moved to other place soon upon the completion of the improvement of the weir and intake gate. However; the Contractor was instructed to clean and rehabilitated properly before leaving the site.</p>	<p>It is recommended that the DCO should inspect and making sure that the cleaning and site rehabilitation are undertaken properly before moving out.</p>

Photos of temporary accommodation available on site	
Hazardous/Chemical Waste	
No storage of hazardous material was found on site and no spillage and leakage.	PPO and DCO should always advise the Contractor to carry out safe and proper handling of the hazardous material/waste
Water Quality and water resources	
<p>Water samples were collected at upstream and downstream of Houay Pouk. Besides the construction activities of Subproject, the clearing and ploughing of many hectares for land for banana plantation nearby the weir; would impact on water quality of Houay Phouk.</p> <p>The details of the water quality analysis result is described in the section 4.7</p>	It is recommended that the collection of upstream and downstream water sampling should be continued for basic parameters.
Traffic and Safety	
With the scope of work, only few trucks and vehicles used during the construction and the main construction area where the machineries are needed is quite far from the communities. No potential anticipated accident would happen. It was confirmed by the village authorities confirmed that so far there have not been accidents happened.	It is recommended that the Contractor should be advised on traffic safety particularly for the drivers.

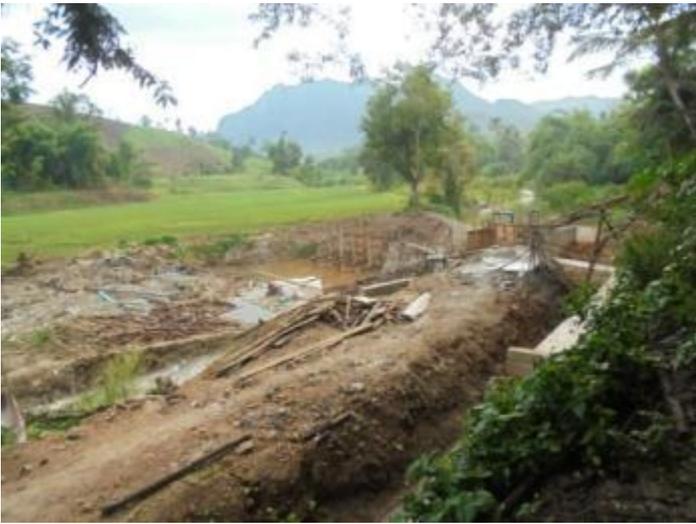
<p>Photo of the wood waste from the construction work</p>	
<p>Construction Camp</p>	
<p>As mentioned in the third Safeguard Monitoring Report of year 1 that the agricultural huts and tents were used as temporary accommodation during the construction. No camp facilities found for the Houay Xo 1&2 as the works have been temporary stopped for wet season. However, one small hut was located nearby the weir structure of Houay Xo 3 where 2-3 workers based.</p>	<p>It is recommended that the temporary hut used during the construction should be removed and the area shall be cleaned.</p>

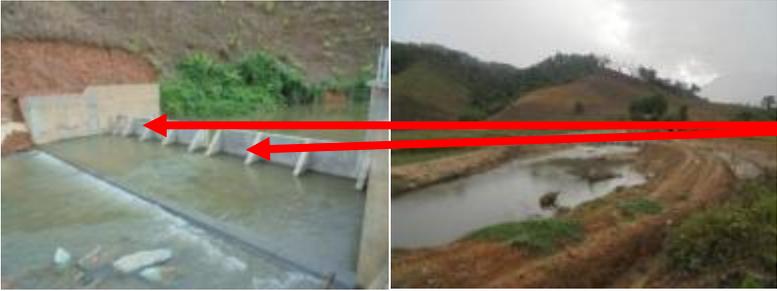
<p>are 2 slots in the middle of each weir for sediment and this can be the fish passage.</p> <p>- Even though the weirs with the concrete structures are new for the Houay XO, but these will not cause much negative impact on fish migration and habitat as there are slots for fish passage and the water level at upstream and downstream is not much different (see the photos)</p> <p>aquatic species reported and found in the Houay Xo are listed in the Annex5</p>	<p>during the dry season if water available to maintain the water level for aquatic resources during the operation.</p>
-----------------------------------------------------------------------------------------------------------------------------------------------------------------------------------------------------------------------------------------------------------------------------------------------------------------------------------------------------------------------------------------------------------------------------------------------------------------------------	-------------------------------------------------------------------------------------------------------------------------

<div style="border: 1px solid black; padding: 10px; width: fit-content; margin: auto;"> <p>gateways for sediment release and fish migration</p> </div>
<p>Photos of weir structures of Houay Xo 1&2</p>

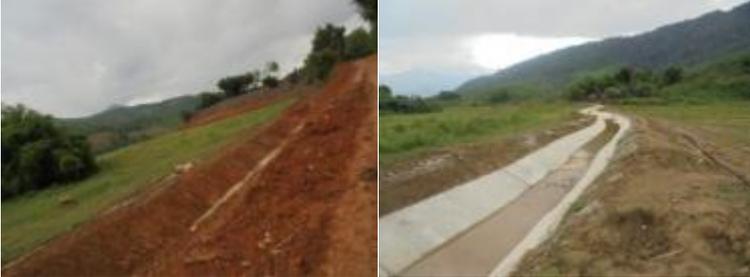
<p>impact on paddy fields and the canal would be filled with sediment and blocked. In general, these areas with potential erosion will be only for short term and at the end of wet season these area will be recovered quickly with natural vegetation.</p>	<p>For long term use of facilities, the WUG should be trained of facilities maintenance to make sure that the materials deposit inside the canal is regularly removed.</p>

<p>Photo of the potential areas subject to erosion.</p>	
<p>Disturbance on Water Flow</p>	
<p>During the site visit, the concrete work on weir structure was being taken place. However, no disturbance on water flow as the water runs through the existing intake gates. no water is released to the paddy field through the canals yet. the water still flow along its natural way.</p>	<p>No actions or mitigations required</p>
<p>Dust and Noise Nuisance</p>	
<p>No potential dust and noise concerns as construction location is very far from residential area.</p>	<p>No action and mitigation measures required.</p>

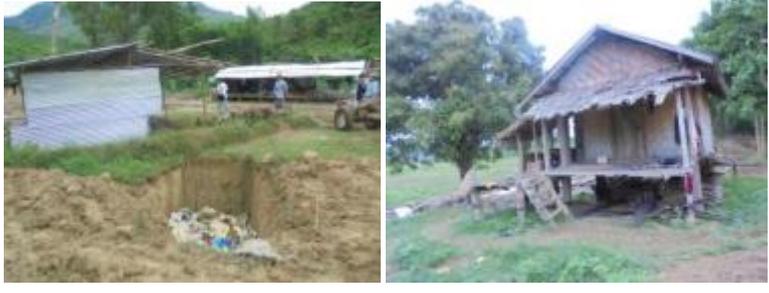
<p>Photos of temporary hut and camp used during construction camp.</p>	
<p>Hazardous/Chemical Waste</p>	
<p>Few drums of chemical materials were observed under the roof of storage house. However, no spillage/leakage was observed on site.</p>	<p>The PPO and DCO has to make sure that proper handling and delivery of such hazardous material is regularly practiced</p>
<p>Water Quality</p>	
<p>There would not be the construction activities that can cause significant impact on water quality of Nam Sat. only the level of sediment load in the water would be increased due to the construction activities. Water samples were collected at upstream and downstream of the Subproject</p> <p>The details of the water quality analysis result is described in the section 4.7</p>	<p>It is recommended that the collection of upstream and downstream water sampling should be continued.</p>
<p>Traffic and Safety</p>	
<p>Potential road accident or safety risk is minimal as the construction activities of the Subproject are distant from the residential area. However, the access road to the construction site is also used by the farmers to their paddy fields</p>	<p>It is recommended that the advice of safe driving should be given to the drivers of the Contractor.</p>

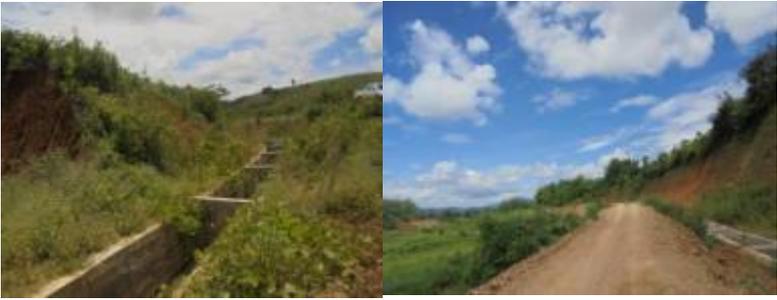
Disturbance of water flows	Proposed mitigation and required action
Soil erosion, silt and sediment deposition:	
As the construction work has been completed for months and the system is now operational. Most of the disturbed areas subject to erosion are covered with natural vegetation. However, there are some small sections along the canal sides sensitive to erosion, but no report concerning the complaints from the local people for this regard.	It is recommended the PPO and DCO should regularly check and carry out removal eroded materials and stabilization of slope should be undertaken based on necessity

Photo of the vegetation along the canal sides of Nam Haad Right Bank	
Disturbance on Water Flow

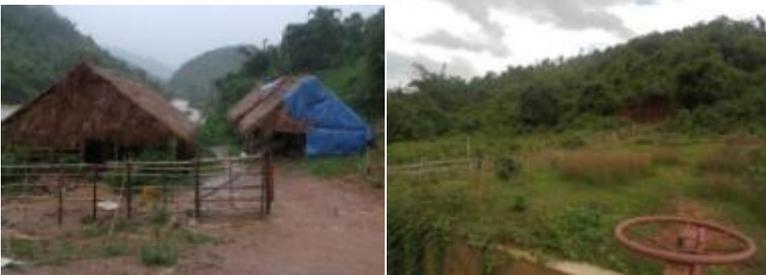
Construction Camp	
The temporary accommodation camp next to the weir structure was displaced	No action and mitigation measures required

Construction camp during and post-construction at Nam Haad Right Bank	
Hazardous/Chemical Waste	
No storage and handling of hazardous material and waste on site	No action and mitigation measures required
Water Quality	
<p>Most of the disturbance on water quality would come from construction activities of Nam Haad Left Bank Subproject and agricultural activities nearby the construction site.</p> <p>The details of the water quality analysis result is described</p>	It is recommended that the collection of upstream and downstream water sampling should be continued.

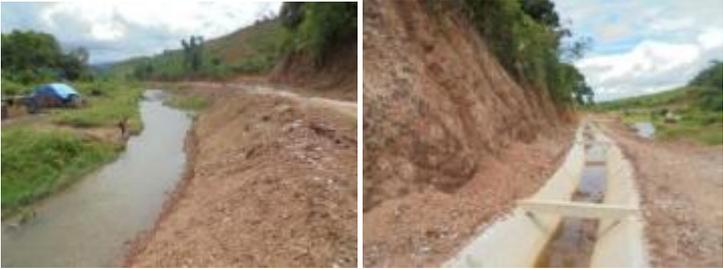
Disturbance of water flows	Proposed mitigation and required action
Soil erosion, silt and sediment deposition:	
<p>As the main canal is close to the stream, some cut material was dumped down slope which would be subject to erosion and scouring by the high flow; particularly during wet season. However, it was confirmed by site manager of the Contractor that redirection of flow would be undertaken to avoid the scouring and destruction of the canal. This would minimize the erosion and scouring potential at some certain level. For the upslope face with steep cut, it seems the cut slope would be subject to erosion as well, but not much because it is mainly covered with highly rock-contained soil (ultramafic rock).</p>	<p>It is recommended the PPO and DCO should regularly check and carry out removal of eroded material and stabilization of slope.</p> <p>PPO and DCO should advise for proper redirection of the some section of stream to avoid potential erosion and scouring. It is recommended that the redirection of flow should be undertaken during dry season.</p>

<p>Photo of the potential areas for erosion and scouring by flow.</p>	
Disturbance on Water Flow	
<p>No any construction activities on main structure of weir for this Subproject, the minor change on flow would be caused by disposed material down slope along the main canal only. However, no complaints or potential impacts has been reported and as mentioned above that redirection of flow will be undertaken.</p>	<p>PPO and DCO should advise for proper redirection of the some section of stream to avoid potential erosion and scouring. It is recommended that the redirection of flow should be undertaken during dry season.</p>
Dust and Noise Nuisance	
<p>No potential dust and noise concerns as construction location is far from residential area.</p>	<p>No action required as the construction has been completed</p>
Borrow Pits/Quarry	
<p>Construction materials; including aggregate for concrete work were supplied by the local supplier.</p>	<p>No action and mitigation measures required</p>

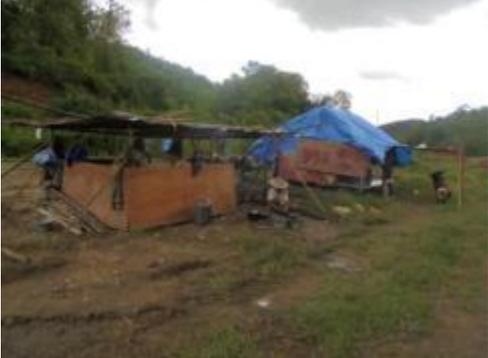
Waste management around the small temporary house is acceptable with good housekeeping. very limited amount of waste is generated on site as there are only 2 workers based in this house and the waste is regularly burned.	PPO and DCO in coordination with DONRE to make sure that the construction site and temporary camp shall be clean with proper waste management
Construction Camp	
Temporary hut was built to accommodate for few workers. It is confirmed that this hut will be moved out before the temporary stop of construction for wet season	No action and mitigation measures required

Photo of temporary hut used as construction camp	
Hazardous/Chemical Waste	
No storage and handling of hazardous material and waste onsite observed. the chemical material was regularly delivered from the station supplying by local supplier	The PPO and DCO has to make sure that proper handling and delivery of such hazardous material is practiced

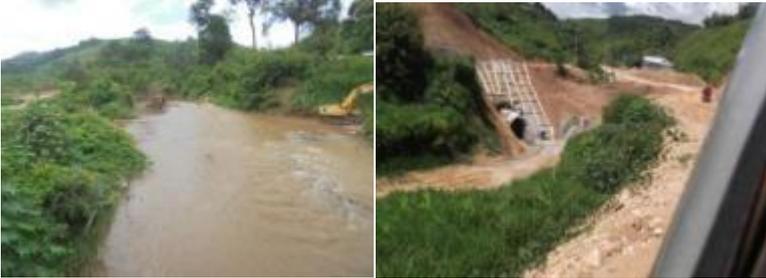
Disturbance of water flows	Proposed mitigation and required action
Soil erosion, silt and sediment deposition	
<p>It is less subject to erosion for this subproject due to topographical location. No areas with steep slope of backfill at high elevation along the canal sides and nearby weir structure are existed. Most of the cut and fill areas are recovered with natural vegetation. However, besides the construction activities, there is sand and gravel dredging along the river by local company and large-scale irrigation project at upstream of Nam Ma Oune Subproject. This would increase the sediment load in the water of Nam Ma Oune.</p>	<p>It is recommended the PPO and DCO should regularly check and carry out removal eroded material and stabilization of slope if necessary</p>

<p>Photo of the sand and gravel dredging along the Nam Ma Oune and government irrigation project</p>	
Disturbance on Water Flow

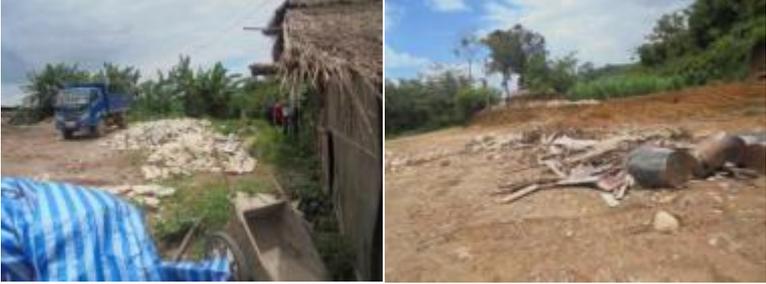
No more activities on borrow pit/quarry and the rehabilitation was undertaken	No action and mitigation measures required
Waste Management	
General construction waste e.g. wood and scrap metals were observed nearby the accommodation camp of the Contractor. It was confirmed by the site engineer that the waste will be moved out from the site as the construction work was completed.	The PPO and DCO in coordination with PONRE and DONRE to check whether the waste is moved out from the site

Photos of the camp area with some scrap metal and wood waste nearby the camp	
Construction Camp	
As mentioned in the previous reports of package 7-1 that 3 houses nearby the road were hired for temporary accommodation during the construction. The houses will be given back to the owners upon the completion of the subproject. During the site visit, there are 4 people living in the camp.	PPO and DCO in coordination with PONRE, DONRE and the owners of the houses to ask the Contractor to clean and rehabilitate the camp to make sure that site is clean before giving back to the owners.

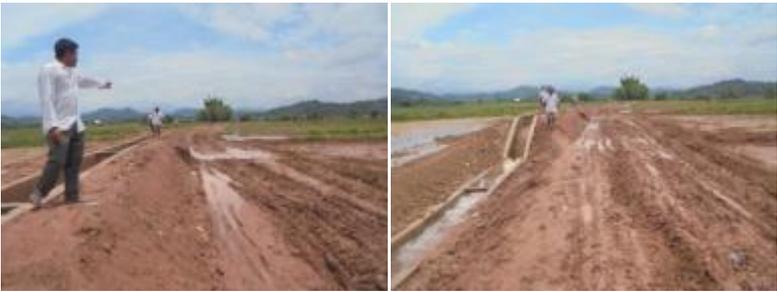
Disturbance of water flows	Proposed mitigation and required action
Soil erosion, silt and sediment deposition	
<p>This Subproject was completed last month. Even though the site rehabilitation was undertaken but several places along the canal sides where canals run through the paddy fields were subject to erosion due to the agricultural tractor uses and paddy field ploughing activities. However; the erosion will be minimize due to availability of topsoil and natural vegetation growth in wet season.</p>	<p>It is recommended that monitoring of PPO and DCO after wet season should be carried out to check the areas to be damaged or eroded for maintenance and advice should be given to the WUGs for regular check.</p>

Photos of the potential erosion areas	
Disturbance on Water Flow	
No concern on water disturbance by the improved structures comparing to structures already existed .	No action or mitigation required.

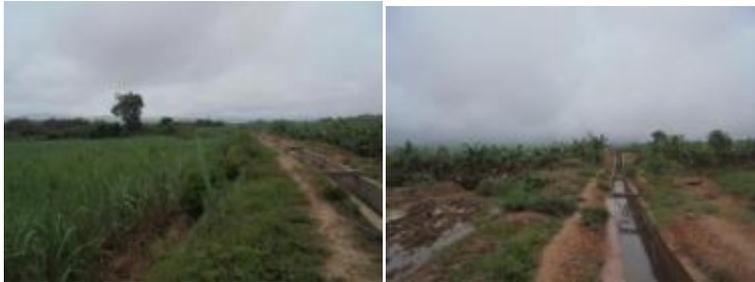
Disturbance of water flows	Proposed mitigation and required action
Soil erosion, silt and sediment deposition:	
As the construction work has been completed for months and the system is now operational. Most of the disturbed areas subject to erosion are covered with natural vegetation. No report received from villagers concerning the complaints from the local people concerning this regard.	No further action required

Photo of the vegetation along the canal sides of Nam Dai 5&6	
Disturbance on Water Flow	
No disturbance on water flow of Nam Dai and water use for paddy field as the construction of the structures both canals and weir has been completed and water is released to the paddy field, no any concerns raised by local community regarding water flow due to the project. However; the villagers reported that there would be less water available for the paddy field as the water is taken by the owner of the banana plantations at upstream of the Nam Dai 6 weir by diverting the water from the tributaries of Nam Dai e.g. Houay Nam Hou and Houay Lek into the storage ponds which use for banana plantation. This would cause the negative impact to the water use of local people at downstream particularly during dry season and early wet	The PPO and DCO should review on the irrigation water use and consult with the owners of banana plantation and other relevant government sectors to make sure that the proposed irrigated paddy fields can get sufficient water for agricultural production.

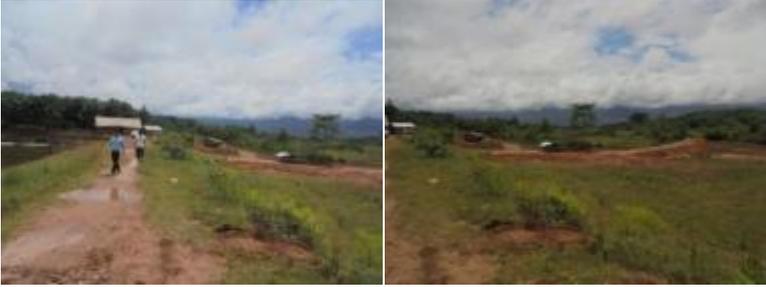
12). Nam Gna 6-Houay Luang

Disturbance of water flows	Proposed mitigation and required action
<p>Soil erosion, silt and sediment deposition</p>	
<p>As the construction work had just started and only 2.57% completed (125m long concrete lining). It has been stopped temporarily for wet season. Erosion and sedimentation is considered as minor for this subproject even though some material excavated from main canal was disposed along sides of the canal, but less subject to erosion as no waterway run through the area and low terrain.</p>	<p>Rehabilitation along the canal sides where necessary upon the completion of earth works is required to avoid the impact to the paddy field of the villagers.</p>

<p>Disturbance on Water Flow</p>		
<p>Most of the work for this Subproject is improving the canals and intake gate. There is no work which would cause potential impact on water flow from this Subproject. No change on flow regime for the stream and water use at downstream comparing to the pre-construction stage.</p> <p>During the dry season only very less or no water discharged to downstream due to level of existing spillway and water level in the reservoir as the water released into the irrigation canal</p>		<p>It is recommended that during the operation the minimum flow should be released to the downstream during the high demand for irrigation to maintain the water required for aquatic resources.</p>

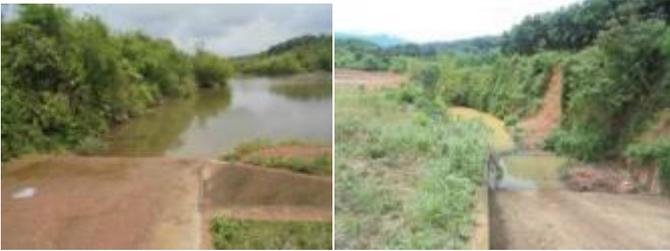
<p>Photos of the reservoir and spillway</p>		
<p>Dust and Noise Nuisance</p>		
<p>No dust and noise concerns reported by the community. The noise and dust would not happen in some particular place as the construction work will be move to place by place in different day along the alignment.</p>		<p>Operation of heavy machineries at night time should be minimize and the speed limit for the driving in the residential area to minimize the dust suppression.</p>

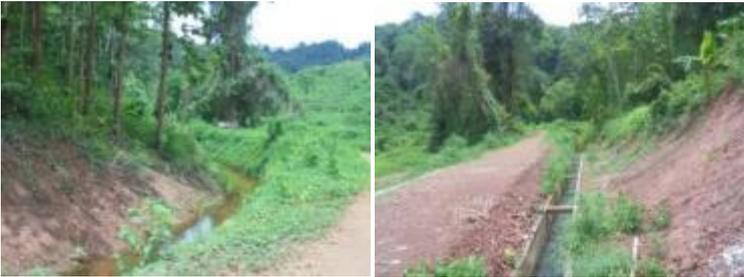
Disturbance of water flows	Proposed mitigation and required action
Soil erosion, silt and sediment deposition	
<p>This Subproject was completed last months ago. No erosion hazard was observed along the canal and nearby the weir structure. On the other hand, the disturbed areas have been gradually recovered with natural vegetation.</p> <p>Currently possible source of the sediment is from the agriculture activities at upstream and downstream of the weir structure; particularly during the wet season.</p>	<p>It is recommended that the watershed management at upstream of weir shall be enhanced by PAFO and PONRE authorities though the existing watershed management plan.</p>

Photos of the natural vegetation along the sides of the canal sides	
Disturbance on Water Flow	
No concern on water disturbance from the construction activities from the Subproject comparing to existing structure.	No action or mitigation required.

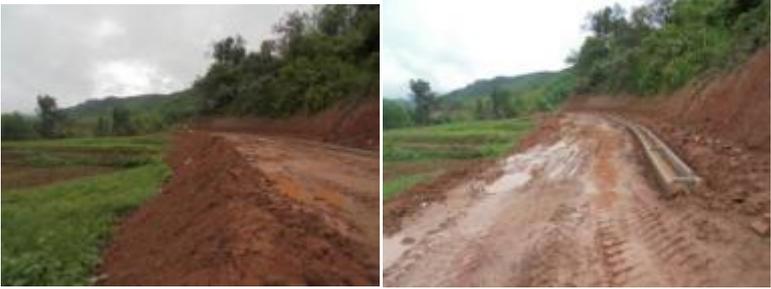
Disturbance of water flows	Proposed mitigation and required action
<i>Soil erosion, silt and sediment deposition</i>	
<p>Excavated material disposed along sides of the canal alignment is subject to erosion but would not be severe as the alignments go through the low terrain areas and most of the sections are far from stream. The prone area to erosion would be occurred during the construction period only.</p> <p>The sediment load in the stream would be also caused by the agricultural activities at upstream, this includes the</p>	<p>It is recommended that the PPO and DCO should advise the Contractor to rehabilitated the along canal sides where necessary upon the completion of earth works, to avoid the impact to the paddy field of the villagers.</p>

Disturbance on Water Flow	
<p>The improvement for the main weir structure is only change of intake gates only. Therefore, there will be no additional impact on water flow of Nam Ngaene from the Subproject. During the site visit, the water was released through the gate to downstream and it was supposed to diverted water partially into the irrigation canal for paddy fields by the end of June.</p>	<p>It is recommended that during the operation the minimum flow should be released to the downstream during the high demand for irrigation to maintain the water required for aquatic resources.</p>
Dust and Noise Nuisance	
<p>It is less dust and noise concerns for this Subproject as it is quite far from the residential area of Nawai village and the construction site is quite far from the main road.</p>	<p>No actions or mitigation measures required</p>

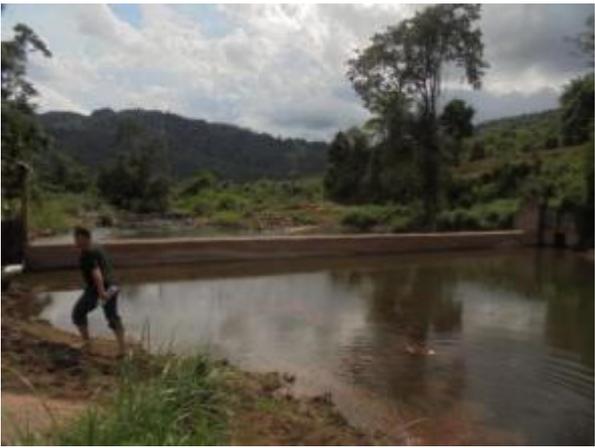
<p>Photos of existing weir structures of Nam Gnaene built in 2008</p>	
<p>Environmental Monitoring</p>	
<p>Up to now, the PONRE and DONRE has engaged only the safeguard monitoring missions. No their own independent monitoring.</p>	<p>It is recommended that besides the involvement in the safeguard monitoring the PONRE and DONRE should plan and implement quarterly or bi-quarterly basis.</p>
<p>Community perception</p>	
<p>Positive feedback was received from the village authorities and villagers of Nawai.</p>	<p>It is recommended that during the operation of the Subproject, the PPO and DCO has to check the water sharing and use by different groups of people and making sure that the villagers can get sufficient water for irrigated areas.</p>

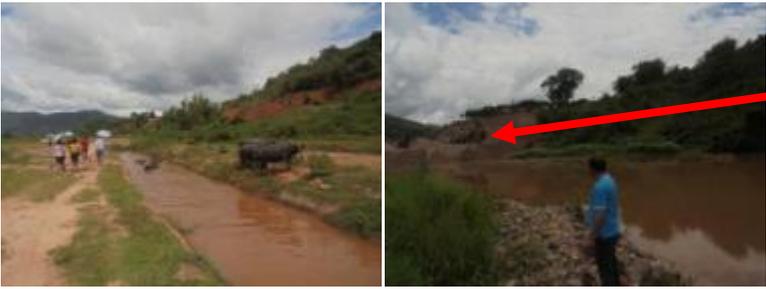
<div style="border: 1px solid black; padding: 5px; display: inline-block;">crushing plant</div>
Photos of the canal alignment with some vegetation and crushing plant nearby the weir structure	
Disturbance on Water Flow	
Water flow in this Subproject can be influenced by different activities at upstream of the Subproject. The improvement of Subproject cause limited disturbance on water flow of Nam Ou due to existing weir structure.	No action or mitigation required.
Dust and Noise Nuisance	
As no more construction activities completed. No any concerns regarding dust and noise issues	No action or mitigation required.
Borrow Pits/Quarry	
Construction materials for this Subproject were sourced during the removal of material from water storage area of the weir	No action or mitigation required
Waste Management	
No domestic and construction waste observed on sites as the rehabilitation of sites was undertaken.	No action or mitigation required

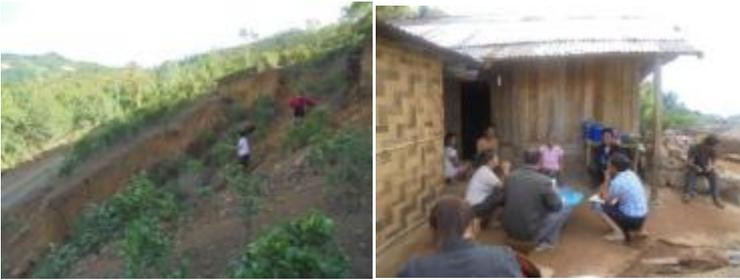
<p>participation of village chief and DCO and PPO and the meeting notes was signed on 24 March 2014.</p> <p>Additional consultation was made during the safeguard monitoring on 9 June 2014 with the AHs and PPO, DCO, safeguard monitoring team and village authority.</p>	<p>2. if the governmental budget is available, the compensation for the lost tea can be made with cash (rate will be based on the provincial standard existed) and there will be compensation for the lost land with new land at Bokong village (no other land plots are available nearby the lost land).</p> <p>However; outcome from the second consultation with witness of Independent Safeguard Monitoring team, the AHs confirmed that they do not need the compensation of the land by land (no compensation for lost land). They requested only the compensation for the lost tea trees with cash.</p>

<p>Photo of the landslide and consultation with the AHs at Mongchao village</p>

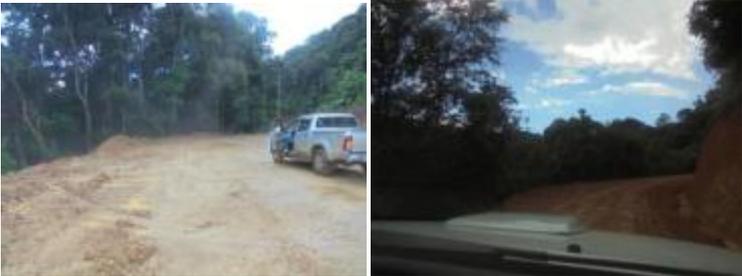
<p>tea plantation or other crops. Lower part of the disposed area is buffered with vegetation which would minimize the erosion, landslide and material movement.</p> <p>No landslide or collapse of the material reported and seen and no complaints received from the villagers.</p>	<p>occurred during the wet season; particularly for the very steep slope.</p>

<p>Photos of the spoil disposal down slope of the road with no tea plantation</p>	
<p>Disturbance on Water Flow</p>	
<p>The culverts have been installed where necessary as per design</p>	<p>The PPO and DCO has to check whether all culverts are effectively installed and operated and additional culverts are needed</p>
<p>Dust and Noise Nuisance</p>	
<p>No issue on dust was observed during the site visit due to the rain. No any complaints received from the communities regarding the noise caused by Subproject activities. On the other hand, as only few heavy trucks and machineries are on site and reportedly no construction work during the night nearby the residential area.</p>

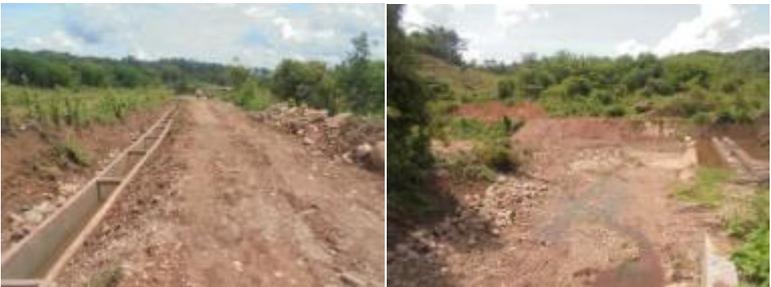
18). Nam Thae Irrigation Subproject

Disturbance of water flows	Proposed mitigation and required action
Soil erosion, silt and sediment deposition	
<p>No sever erosion and potential impact was observed as the topographical location of the area in the Subproject area is mainly flat. However, the area beside the weir structure is subject to erosion, it is confirmed that the rip rap would be used to stabilize the slope area.</p> <p>The sediment load in the stream is quite low and most of the water was diverted into the irrigation.</p>	<p>It is recommended that the PPO and DCO should advise the Contractor to rehabilitated the along canal sides where necessary upon the completion of earth works, to avoid the impact to the paddy field of the villagers.</p>

Disturbance on Water Flow	
<p>The construction work has not been completed, but temporarily stopped for wet season. During the site visit, the disturbance on water flow in the stream was observed as the water was diverted into the irrigation canals on the left bank of the weir for paddy fields.</p> <p>The improvement of weir structure and canals would not cause much additional impact on water flow of Nam Thae.</p>	<p>It is recommended that during the operation the minimum flow should be released to the downstream during the high demand for irrigation to maintain the water required for aquatic resources.</p>

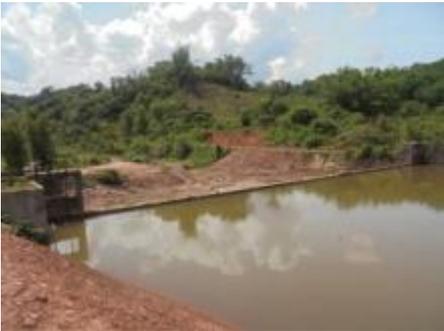
<p>Photos of weir structures of Nam Thae</p>

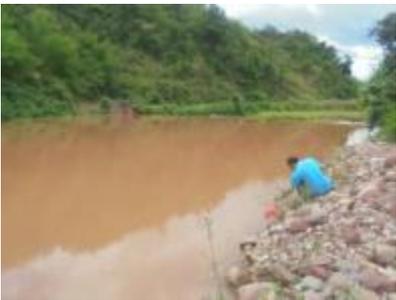
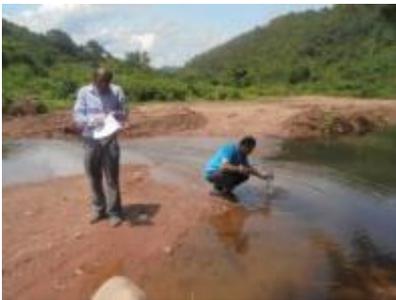
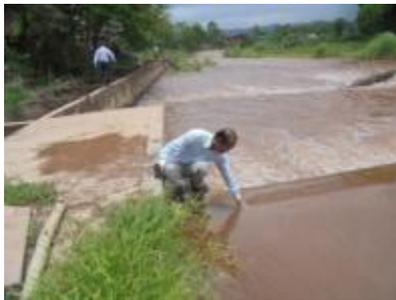
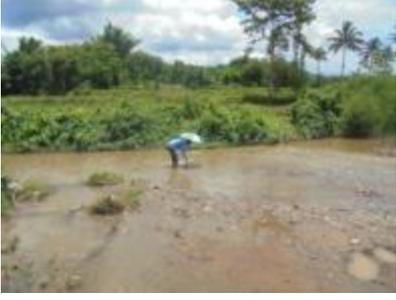
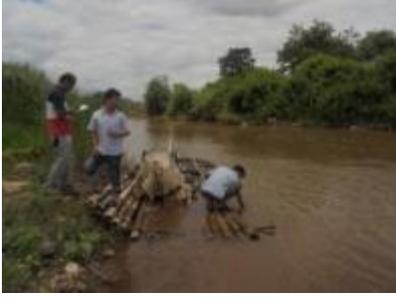
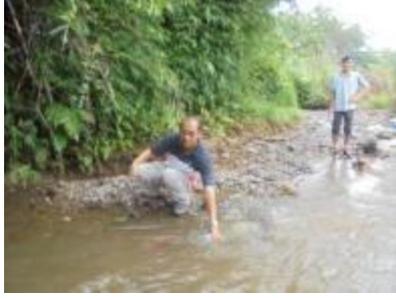
Figure 4-1 Photos of water samplings in Subprojects

Water sampling at upstream of the Nam Ou Subproject	Water sampling at upstream of the Nam Thae Subproject	Water sampling at upstream of the Hong Kong Subproject

water sampling at downstream of the Nam Haad Subproject	Water sampling at downstream of the Nam Ma Oune Subproject.	water sampling at upstream of the Nam Houay Xo Subproject

were collected during the previous missions. The coordinate points of each sampling site are indicated in the table 4-2 and photos of water sampling are shown in Figure 4-1.

The methods and process used for the sampling and analysis is the same used for the previous missions. The parameters include BOD, COD, TSS, PH, temperature, DO and Faecal Coliform, which were proposed in the IEE report. The analysis of water samples for all parameters was conducted in the Lab. The results of water quality are shown in the Annex 2.

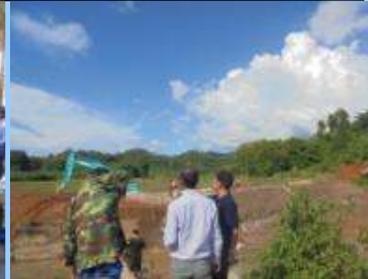
Site visit of Nam Pouk construction site
